Mobile Intel® Celeron® Processor on .13 Micron Process in Micro-FCPGA Package

Specification Update

March 2004

Document Number: 251309-018

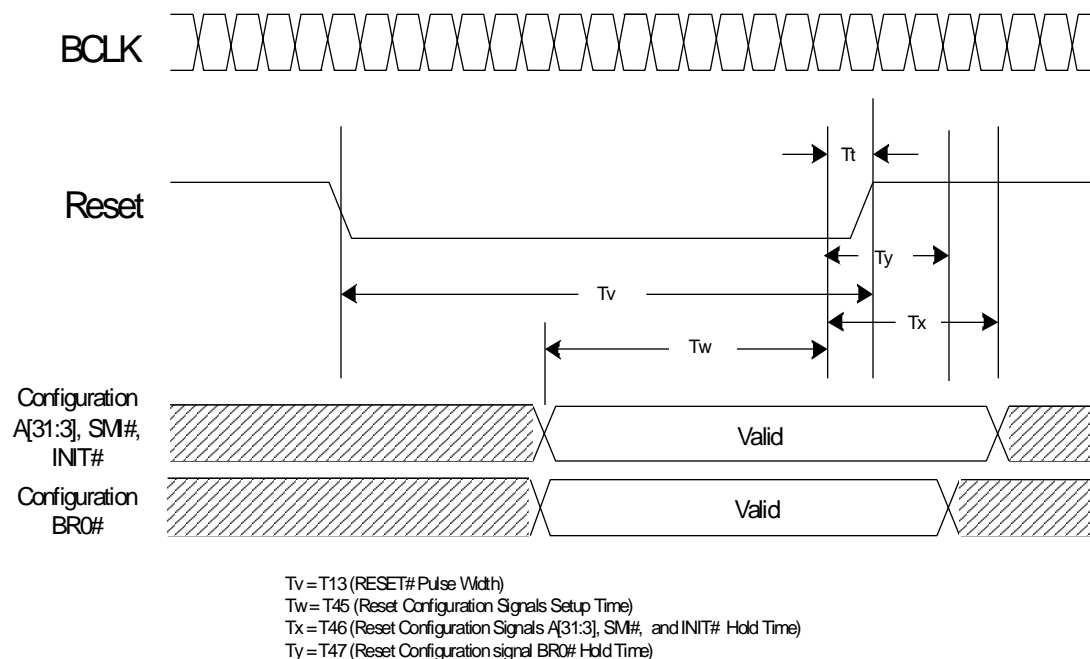
Figure 12. System Bus Reset and Configuration Timings

The BR0# maximum hold time has changed to 2 BCLKs. This change will be shown in the “System Bus AC Specifications (Reset Conditions)” table and “System Bus Reset and Configuration Timings” figure of the *Mobile Intel® Celeron® Processor on .13 Micron Process in Micro-FCPGA Package Datasheet*. This change will be incorporated in the next revision of the datasheet.

The following figure will be modified to reflect this change:
